January 2014

RED HILL VALLEY PARKWAY

Performance Review after Six Years in Service

Report Number: 13-1184-0026

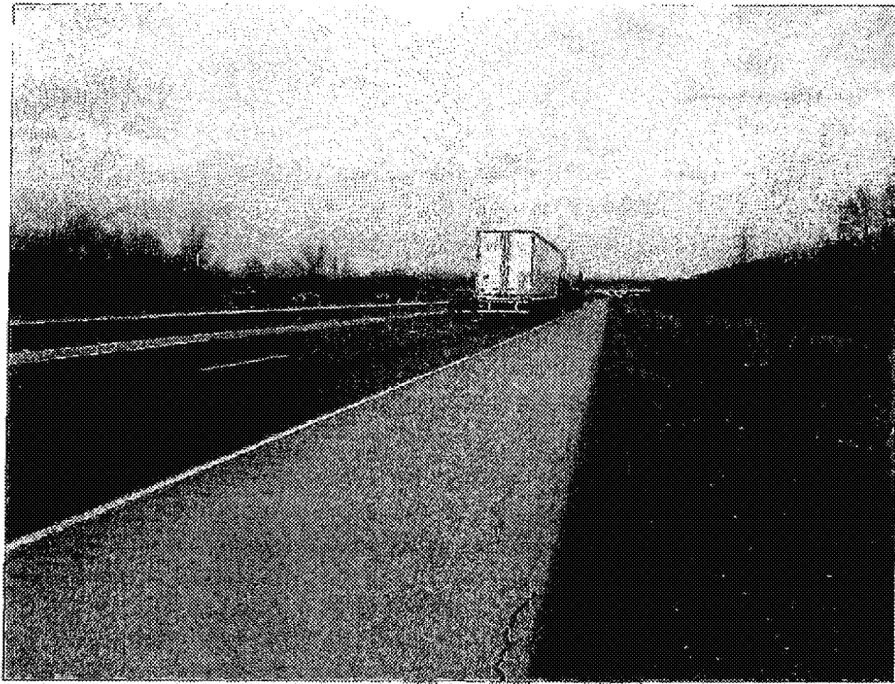
The visual condition inspection was completed by members of Golder's Pavement and Materials Engineering Group in the spring of 2013. The pavement was generally in good condition with limited surface distresses being observed. Pavement edge cracking was present in the shoulder in numerous locations and was slight to moderate in severity. Figure 1 shows an example of the pavement edge cracking. There was also frequent cracking observed in the paved shoulder along the edge of the driving lanes.

Figure 1: Pavement edge cracking in shoulder

The cracks in the paved shoulder along the edge of the driving lanes should also be routed and sealed to stop the ingress of water.

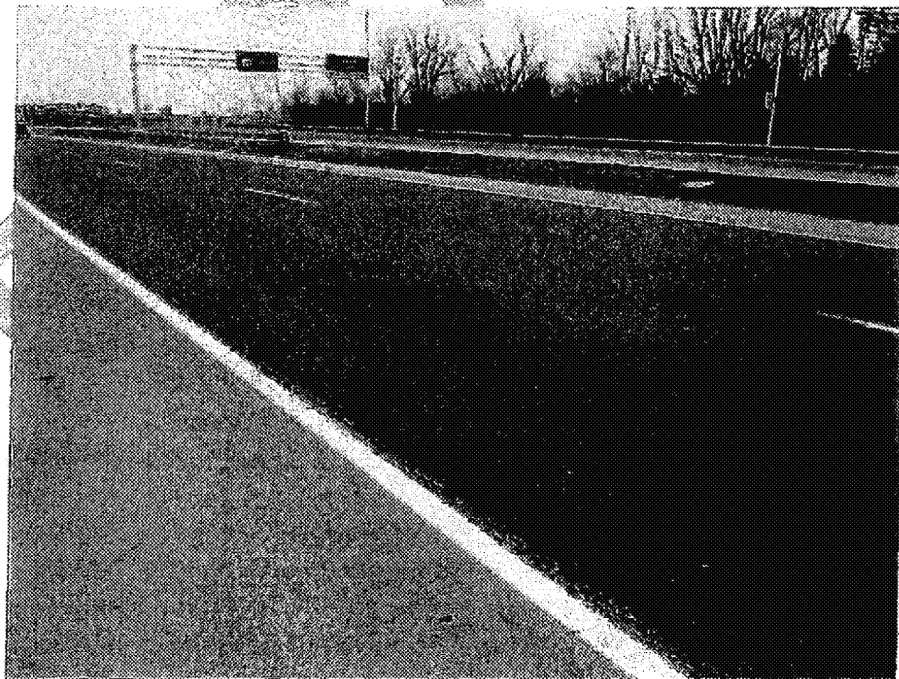
Slight to moderate generally longitudinal cracking was observed in portions of the north and south bound lanes of the pavement. The cracking was primarily in the outside lane (Lane 2). An example of moderate cracking location is shown in Figure 2. The cracking is anticipated to be of top down nature.

Figure 2: Longitudinal top down cracking on RHVP

The top down longitudinal cracking is most visible at the end of the RHVP that is closest to the QEW. The FWD testing clearly indicates that the subgrade is the softest along this section of the RHVP.

In order to remedy the longitudinal top down cracking, it is recommended that the surface course SMA be milled and a new surface course mix be placed at selected locations. At a minimum the milling and overlaying should be carried out on sections where the most frequent top down cracking is observed. Based on our pavement visual condition inspection, the minimum total length of the sections where mill and overlay is required would be about 2.5 km. The exact locations for the milling and overlaying should be determined on site. It is also recommended that if there is any debonding of the underlying SP 19.0 layer observed during the milling and overlaying operation, the debonded SP 19.0 layer should also be removed.
