**CANADIAN TECHNICAL
ASPHALT ASSOCIATION
PROCEEDINGS**

Eight-Year Performance of a Recycled Freeway Surface in Ontario

Pamela Marks, P.Eng.
Senior Bituminous Engineer
Ministry of Transportation Ontario
Toronto, Ontario

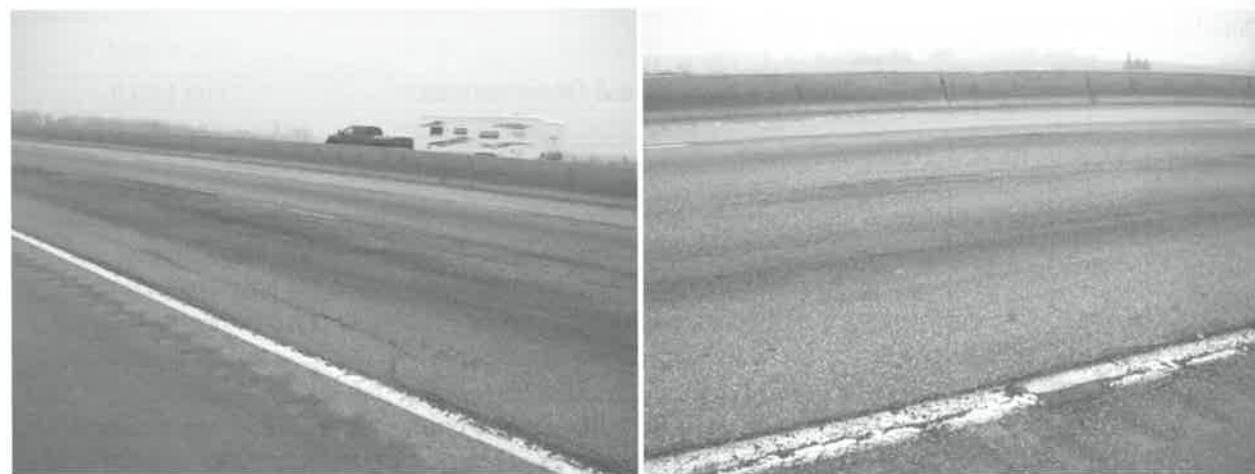
This section exhibited more distresses than the other westbound sections, with segregation and a rich appearing mat immediately evident and progressing to extensive slight and frequent moderate ravelling, a few areas of moderate flushing, and localized rutting after one year in service.

By the third year the surface looked better than expected. Although still segregated, traffic had kneaded the mat and tightened up the surface texture resulting in no additional ravelling, although one 150 mm pothole had appeared. Review in successive years showed no change until 2006, with severity and extent of the distress increasing and the flushed surface reappearing. Cracking was limited over the section with the extent of the slight transverse and longitudinal cracks that appeared in the third year changing from few to extensive for the longitudinal cracks and frequent for the transverse cracks in 2007. Figure 2 provides a visual indication of the condition of this section in 2007.

Figure 2. Distresses in Taisei HIR Section in 2007 after Eight Years in Service

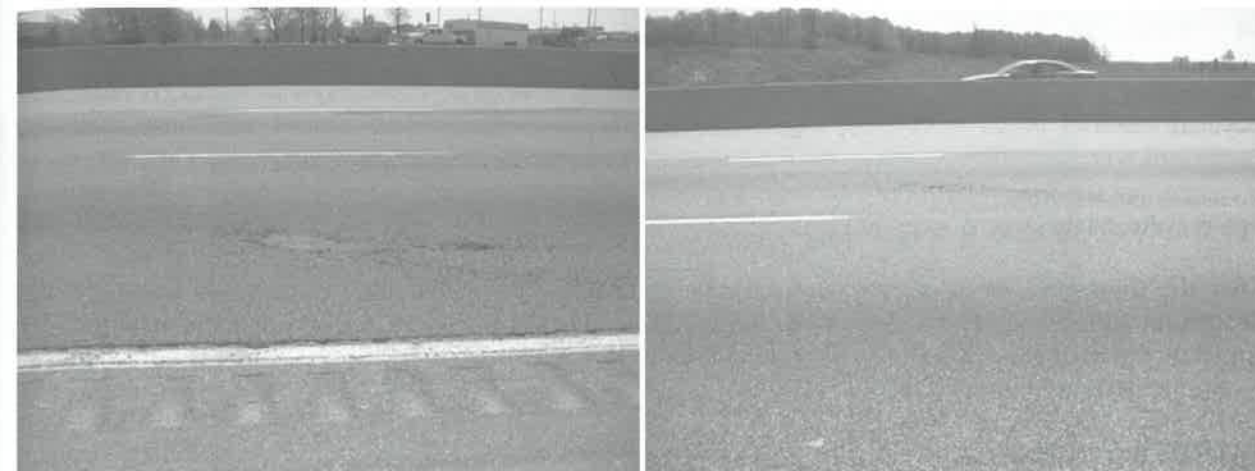
This section represented the normal procedure and therefore, was used as the control section from which to evaluate all the other demonstration sections. Surprisingly, the control section did not perform as well as some of the other sections, with distresses evident mainly due to poor workmanship. Distresses identified at the initial stages included ravelling that was a direct result of segregation of the mix during construction. End-load segregation occurred throughout, with 24 areas exhibiting moderate segregation milled and replaced. Review after one year showed very slight ravelling at midlane and centreline throughout the section.

By year three the mat was of a fairly uniform texture and end-load segregation had lessened due to traffic kneading as noticed in the Taisei Rotec section. In general, the ravelling had not changed but very slight longitudinal cracking was evident frequently along the joints and one 150 mm pothole had appeared. No changes were noted until after the fifth year (2005), when frequent moderate ravelling of the end-load segregated areas that were not repaired was observed and a few potholes had appeared. The frequent transverse cracking was observed in early 2007 as slight, the longitudinal joint cracking moderate and intermittent slight midlane cracking had developed. Overall, the section performed satisfactorily as illustrated in Figure 3, although not as well as expected due to equipment and workmanship issues.

Figure 3. Condition of New DFC Section in 2007 after Eight Years in Service

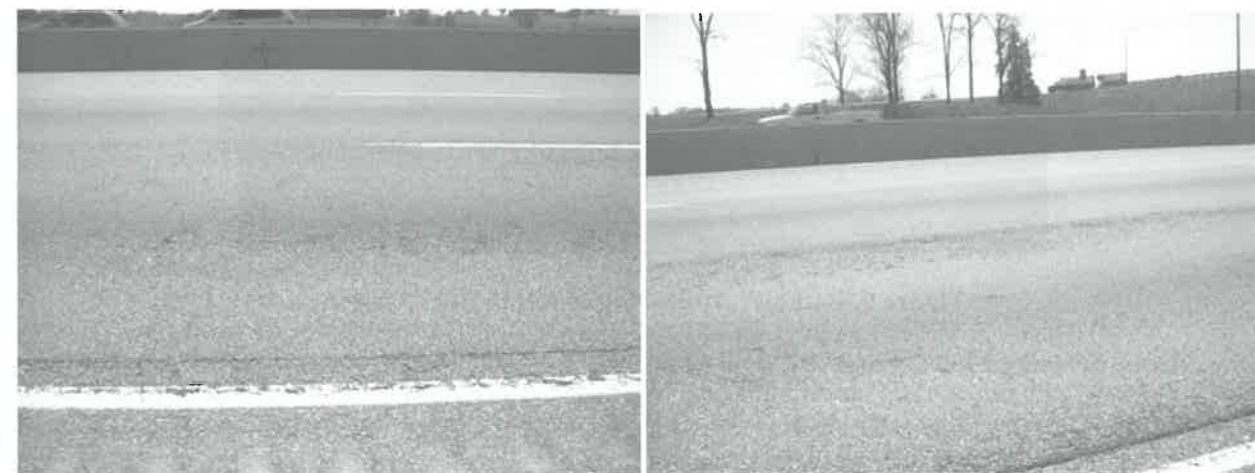
Three patch repairs were made to this section although they were limited to repair for roller pick-up and not for segregation. The section was the smoothest and after one year only exhibited a few areas of very slight ravelling. It was in excellent condition with both the longitudinal joints and mat texture performing very well and no real change in performance noted until year six.

By year six the ravelling was moderate and occurring frequently with some potholes starting. In addition, slight to moderate longitudinal joint cracking and slight transverse cracking was observed throughout with a few multiple to alligatored longitudinal cracks of slight severity accounting for a sharp drop in the pavement quality. The centreline joint exhibited no distresses, although a few potholes had appeared along the ravelled outside E/P. Overall this section displayed excellent performance as illustrated in Figure 4.

Figure 4. Performance of Martec HIR Section

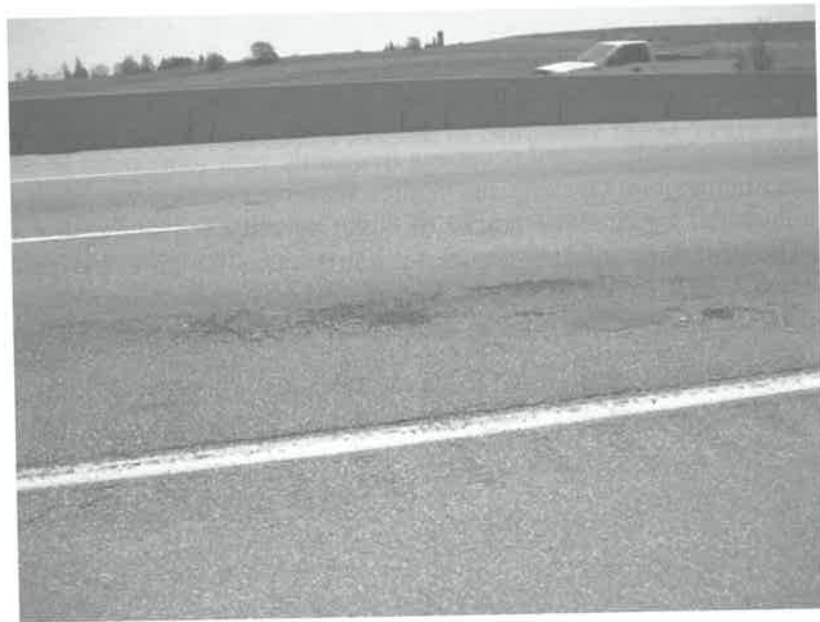
By 2005, the centreline longitudinal joint crack was slight throughout, the E/P was exhibiting frequent slight cracking and by 2007 it had progressed throughout the entire section, although it was not ravelling like the Martec HIR section. Other distresses had also appeared in 2007 including frequent moderate ravelling in the wheel paths and within the areas of end-load segregation, a few small potholes, intermittent slight wheel path cracking, and slight transverse cracking had appeared. Figure 5 shows the condition of one of the potholes within the RHM DFC section.

Figure 5. Potholes Appearing in RHM DFC Section

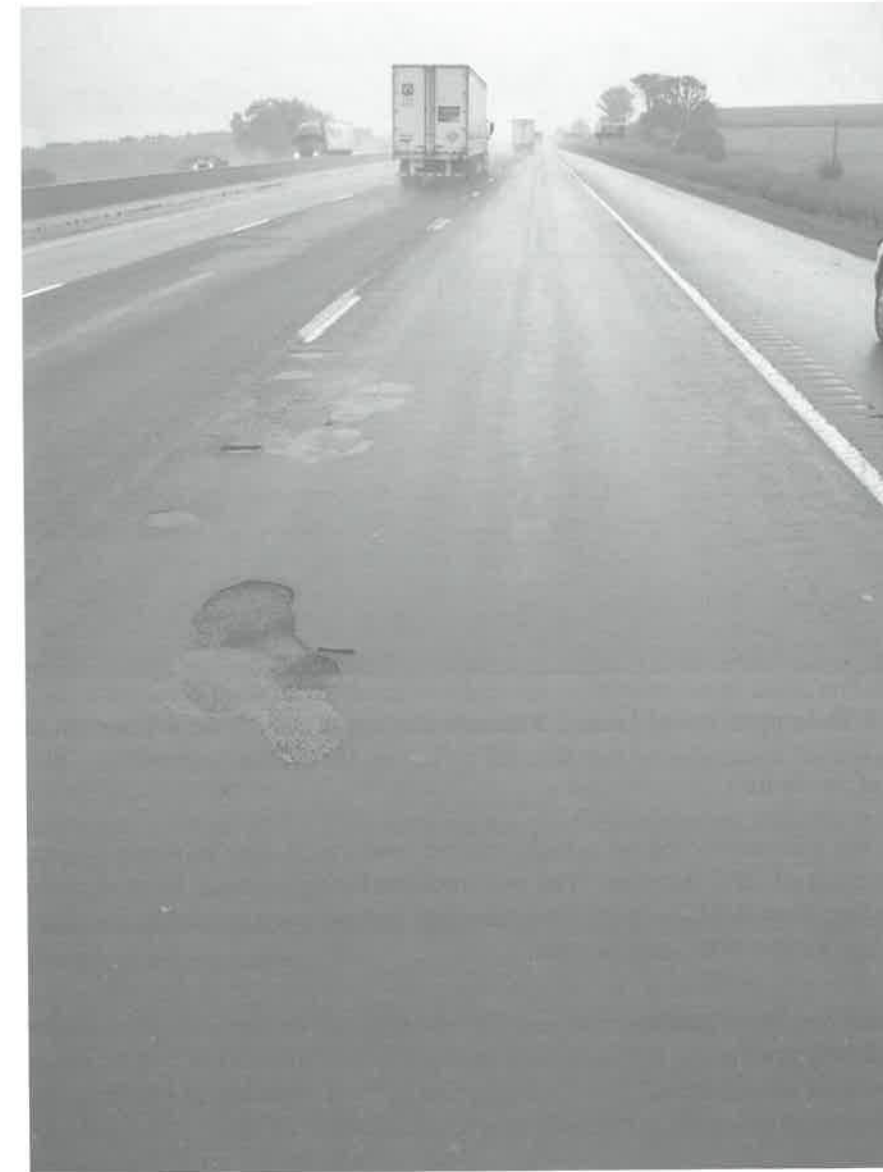
After one year, this section (L3) showed no distresses. Slight ravelling throughout with few small diameter patched holes were observed during the third year review. By the fifth year, the micorsurfacing showed a few areas of very severe ravelling in addition to potholes as shown in Figure 6. The potholes could have resulted from reflected end-load segregation in the underlying DFC. The section was resurfaced later that year (2004).

Figure 6. Severe Ravelling and Potholes in Lane 3 Micorsurfacing

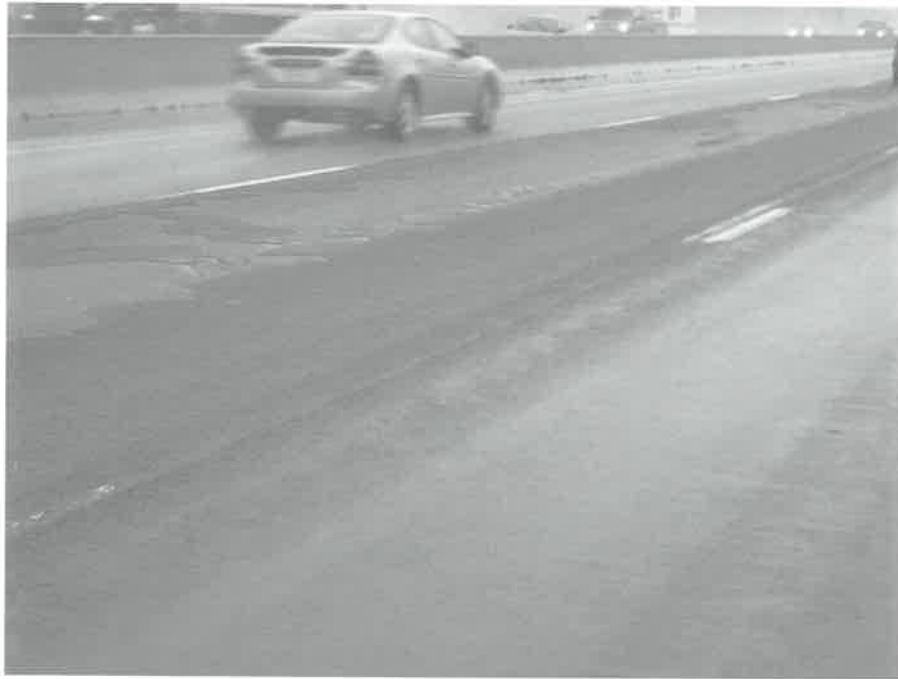
Lane 2 was placed in 2000 and showed immediate evidence of poor workmanship at the start up locations. In 2002, the surface was rough and in a few locations the micorsurfacing was delaminating. Delaminated areas varied in size from small spots to up to 140 m². The conditions continued to deteriorate to frequent very severe delaminating of the micorsurfacing. In 2004, sections of the micorsurfacing were peeling off throughout, as shown in Figure 7. The delamination could have resulted from reflected load end segregation in the underlying DFC. Tack coat was not specified on this contract and the very severe delamination could have been directly linked to its' absence.

Figure 7. Delamination of Lane 2 Microsurfacing in 2004 after 4 Years in Service

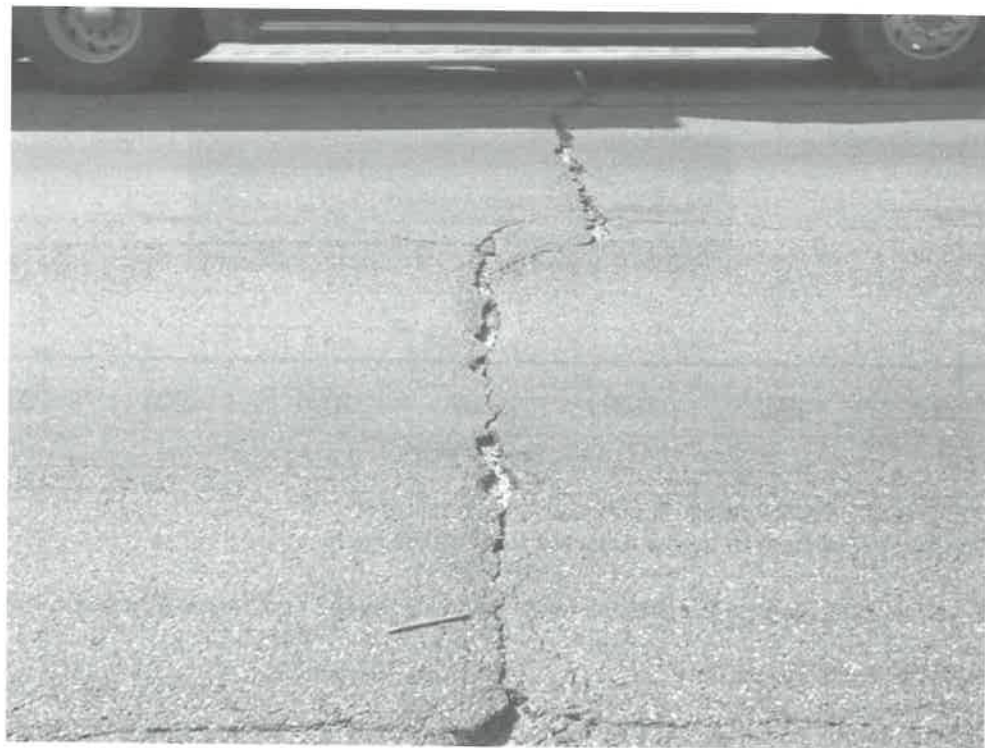
The field review of the DFC pavement was carried out in two 250 m locations. Transverse cracks were occurring every 30 m and appeared to be located above existing concrete joints. Some transverse cracks were sealed, however slight alligator and multiple cracking, raveling and some potholing were present at the transverse reflection cracks (Figure 6). Transverse crack widths varied from 25 to 75 mm. Otherwise, the DFC mix was performing well, with very few locations of raveling observed.

Figure 6. Typical Raveling of Transverse Cracks in Dense Friction Course (DFC) Pavement

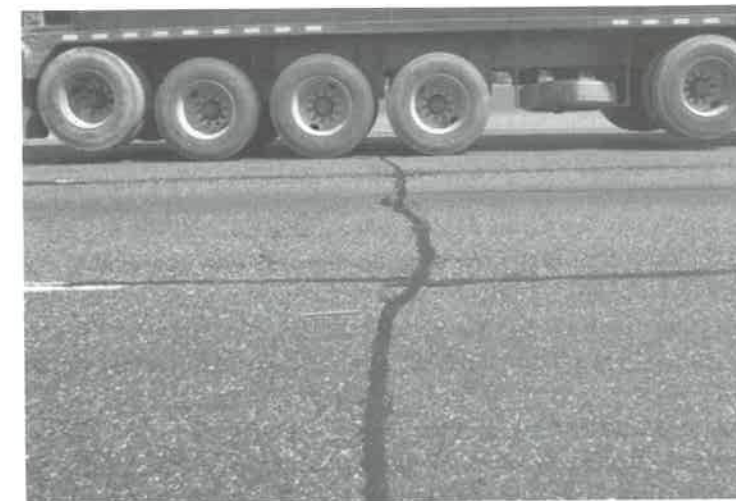
Figure 7. Sealed Transverse Crack in Stone Mastic Asphalt (SMA) Surface

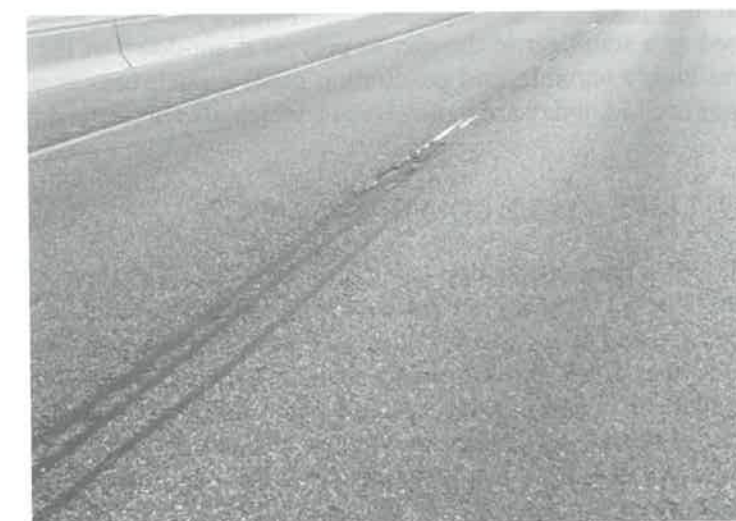
The field review of the SMA pavement was also carried out in two 250 m locations. The most westerly section of the SMA, which was the first constructed, was exhibiting significantly more distresses than the rest of the SMA. Initial construction issues were the likely cause of these distresses. Transverse cracks occurred randomly and varied in separation from 5 to 25 m. All transverse cracks were rout and sealed and in good condition (Figure 7). Very few transverse cracks had multiple cracks propagating from them. The longitudinal joint between Lanes 1 and 2 was raveling and potholing throughout, most likely the result of poor compaction at the joint, and workmanship issues with the new SMA mix (Figure 8).

Figure 8. Sealed Longitudinal Joint, Exhibiting Multiple Cracks, Raveling, and Potholing in Stone Mastic Asphalt (SMA) Surface

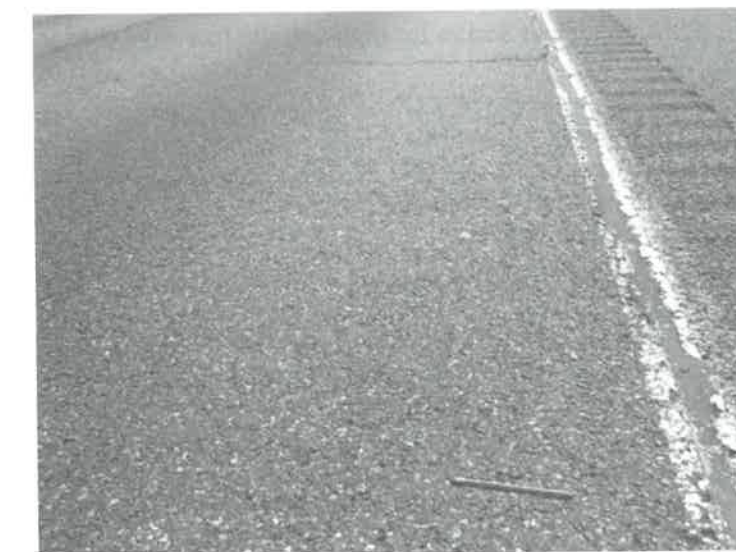
Several locations of moderate raveling were observed (Figure 9). This raveling was also evident in areas of pavement edge rumble strips, which had severely deteriorated. Raveling may be the result of drain-down occurring during placement, since asphalt plant problems at the start of construction resulted in variable asphalt cement content and fibre addition.

Figure 9. Raveling in Stone Mastic Asphalt (SMA) Surface
