January 2014

RED HILL VALLEY PARKWAY

Performance Review after Six Years in Service

Report Number: 13-1184-0026

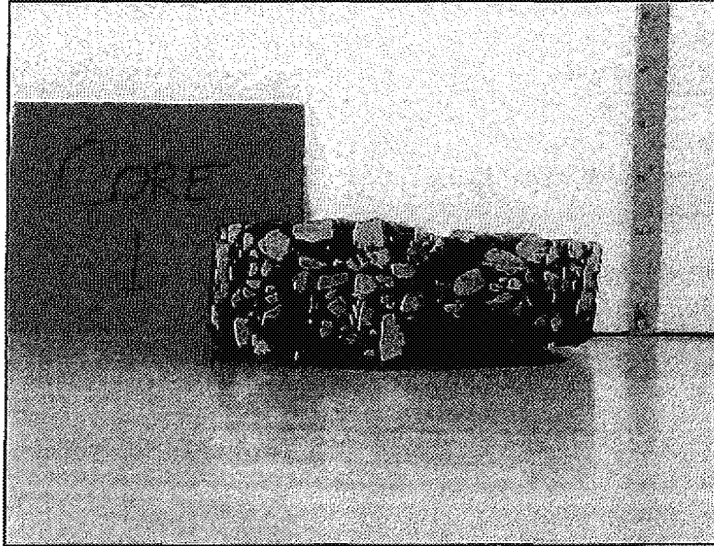
Photo 1: Side View of Core 1

Core	Core Thickness (mm)	Crack Depth from Surface (mm)	Comments
1	39 mm	39 mm	Top lift of asphalt (SMA) debonded from second lift. Only top lift was extracted. The crack was throughout the thickness of the top lift and was not observed to be in the second lift.
2	248 mm	92 mm	The core was the entire thickness of asphalt in the pavement structure. The top two lifts of asphalt had debonded from the remainder of the core. The cracking was throughout the thickness of the top two lifts of asphalt.
3	250 mm	46 mm	The core was the entire thickness of asphalt in the pavement structure. The top two lifts of asphalt had debonded from the remainder of the core. The cracking was throughout the thickness of the top lift of asphalt and partially through the second lift of asphalt.
4	40 mm	40 mm	Top lift of asphalt (SMA) debonded from second lift. Only top lift was extracted. The crack was throughout the thickness of the top lift and was not observed to be in the second lift. While the core was being drilled, water was coming out of voids in the surrounding pavement surface.

As shown in Table 1, the cracks were found to be within the top of maximum top two layers of asphalt. The top asphalt layer and second layer were often debonded from the deeper layers of asphalt. While Core 4 was being drilled, water from the drilling activity was coming out of the pavement surface through surrounding voids.
