**CANADIAN TECHNICAL
ASPHALT ASSOCIATION
PROCEEDINGS**

Eight-Year Performance of a Recycled Freeway Surface in Ontario

Pamela Marks, P.Eng.
Senior Bituminous Engineer
Ministry of Transportation Ontario
Toronto, Ontario

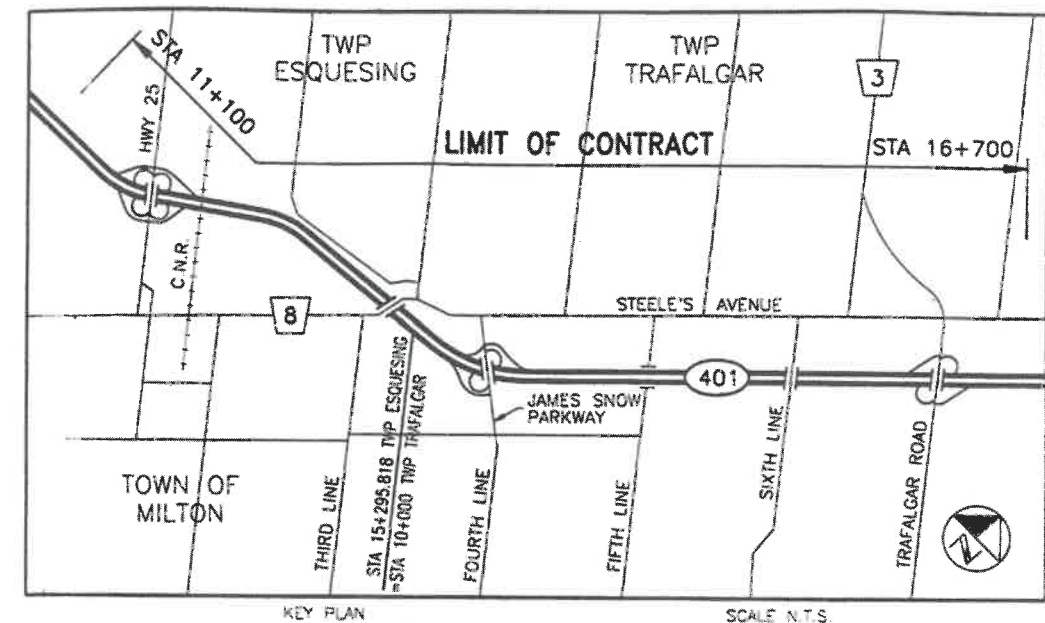
Figure 1. Location of Highway 401 Stone Mastic Asphalt (SMA) Trial near Milton, Ontario

Contract 96-50 called for two lift resurfacing of a milled surface on Highway 401 from 1.4 km east of Trafalgar Road westerly to 1.0 km west of Highway 25 (Figure 1). The work consisted of milling 40 mm (actual depth was 55 mm) and replacing with 40 mm of SMA over 40 mm of HDBC for the eastbound lanes and 40 mm of DFC over 40 mm of HDBC of the westbound lanes. Contract quantities were 243,767 m² of DFC, 255,892 m² of SMA and 281,773 m² of HDBC.

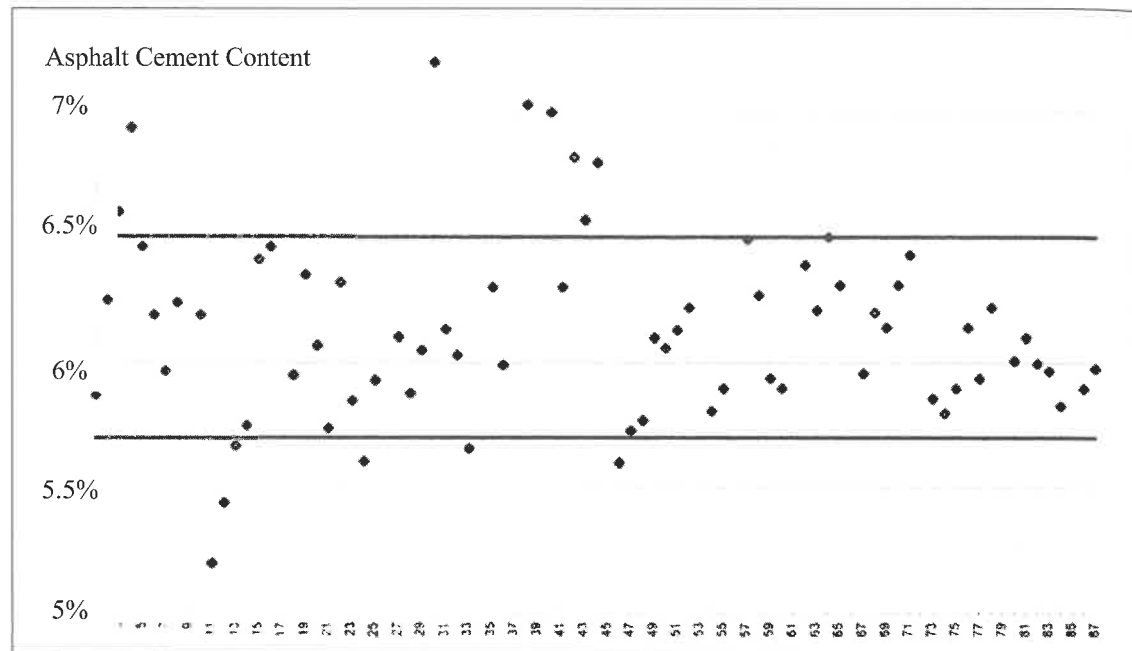
Figure 2. Quality Control Chart of Asphalt Cement Content on SMA Trial

Control charts indicated that the production process was out of control over the first several days of paving (Figure 2). High variability in asphalt cement content produced flushing in about one-third of the eastbound Lane 3 (outside lane) starting at Highway 25, much of which was removed and replaced. This was attributed to plant problems. There were also problems related to the addition and dispersion of the cellulose fibre. The contractor used a drum mix plant with automated filler and fibre addition, but it still resulted in inconsistent addition of each component. Construction records also show that the contractor was not achieving the targeted 94 percent compaction (typically achieving 90 to 92 percent).

The Project Construction Report had the following comments: "SMA proved to be difficult to produce, since the volume of fibres was clogging the plant. It worked fine, so long as the operation was continuous, but when work had to stop for any length of time, there was a delay in re-start due to the mix."

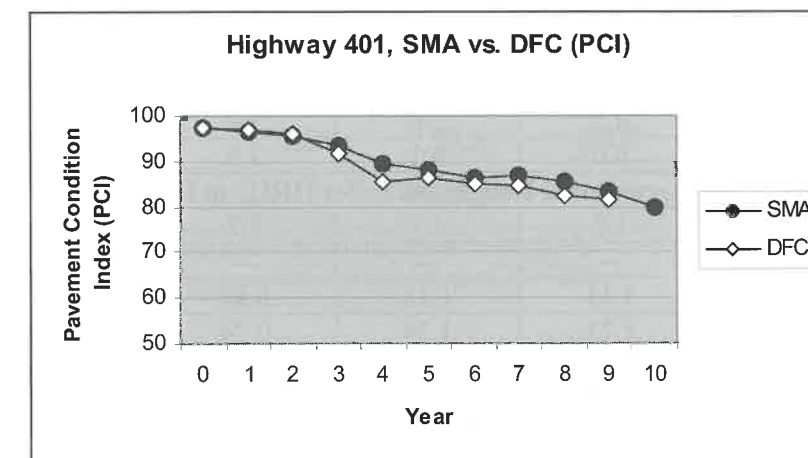
Figure 3. Pavement Condition Index (PCI) for SMA and DFC

The Ministry's main pavement performance indicators are the Pavement Condition Index (PCI), which is a measure of pavement serviceability [4], the IRI and the Distress Manifestation Index (DMI). These indicators are measured annually and stored in the Ministry's Pavement Management System (PMS2) for network and project level evaluation [5]. The PCI, IRI and DMI for the ten-year performance period of 1996 -2006 of the Highway 401 SMA and DFC trial are presented in Table 3. Figures 3 and 4 are graphical plots of the two main performance indicators: PCI and IRI.

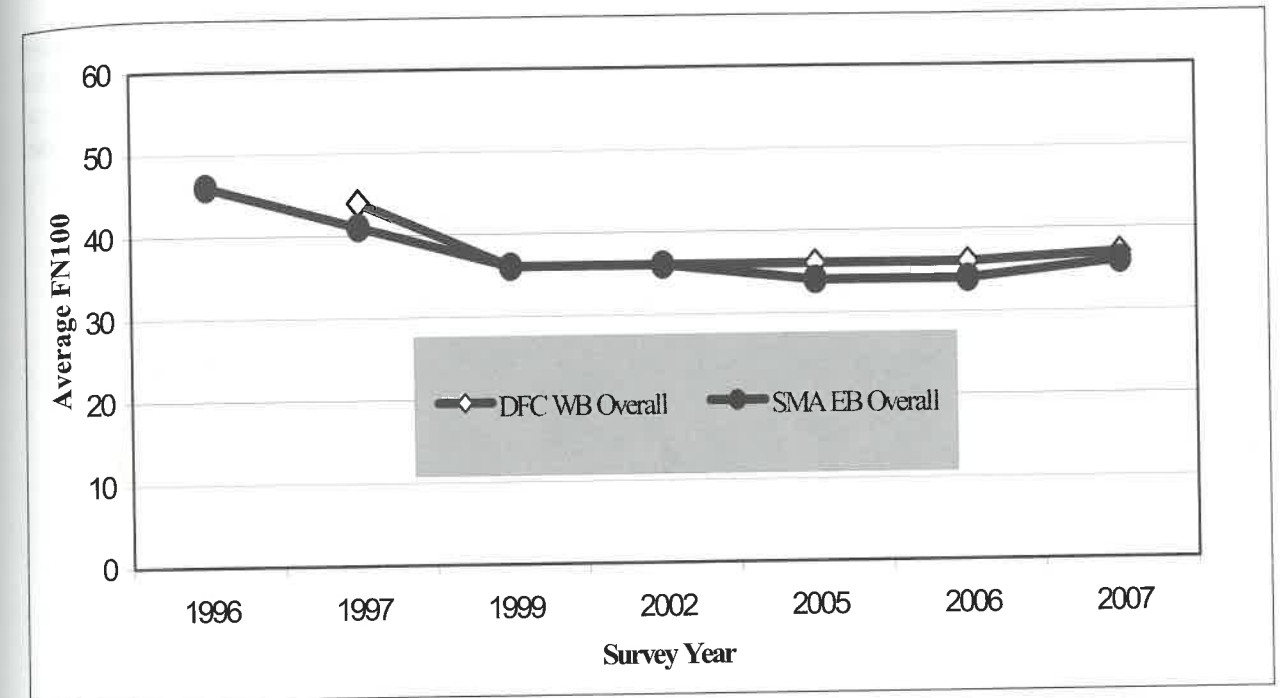
Figure 5. Friction Test Results for Stone Mastic Asphalt (SMA) and Dense Friction Course (DFC)

Periodic friction measurements of the SMA and DFC on the Highway 401 trial were made with the Ministry's ASTM E-274 brake-force trailer. Because of flushing issues on the first several days' production of SMA, friction measurements were taken on both the SMA and DFC in the first year after construction. The friction testing was continued as part of the long-term monitoring program for this trial project. The friction testing was carried out at a test speed of 100 km/hr. Considering that both the DFC and SMA mixes used the same Marmorata traprock coarse and fine aggregate, the friction results are very similar. The friction testing results are graphically presented in Figure 5. These results are in the acceptable range, comparable to other premium surface mixes with similar aggregates types.
